# Rebuilding The Yamaha Vision Motorcycle TCI Electronic Igniter Module / Electronic Ignition / Transistor Controlled Ignition

### Component List for Yamaha Vision Hitachi 12-06 TCI ignition

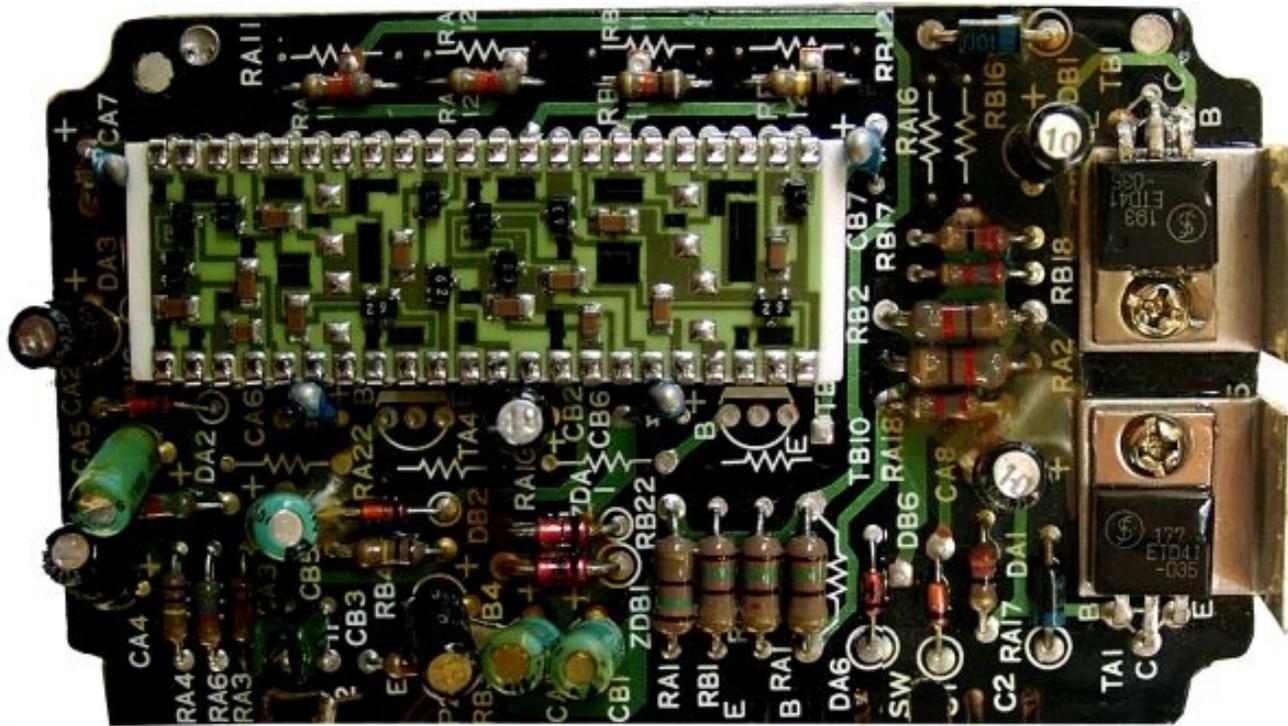
TCI Circuit Board

Photo at left is TCI box with "porthole" cut in bottom to view top of circuit board

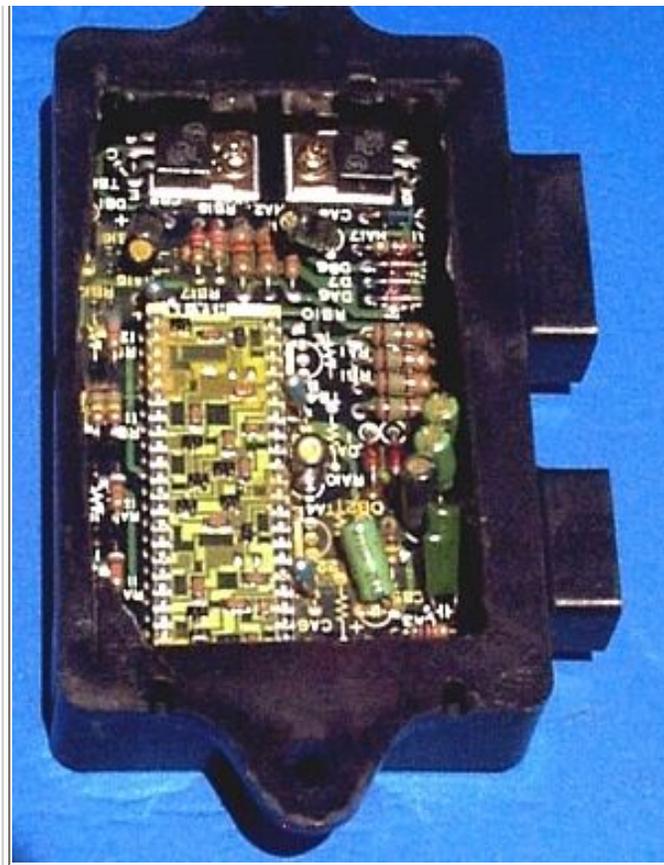
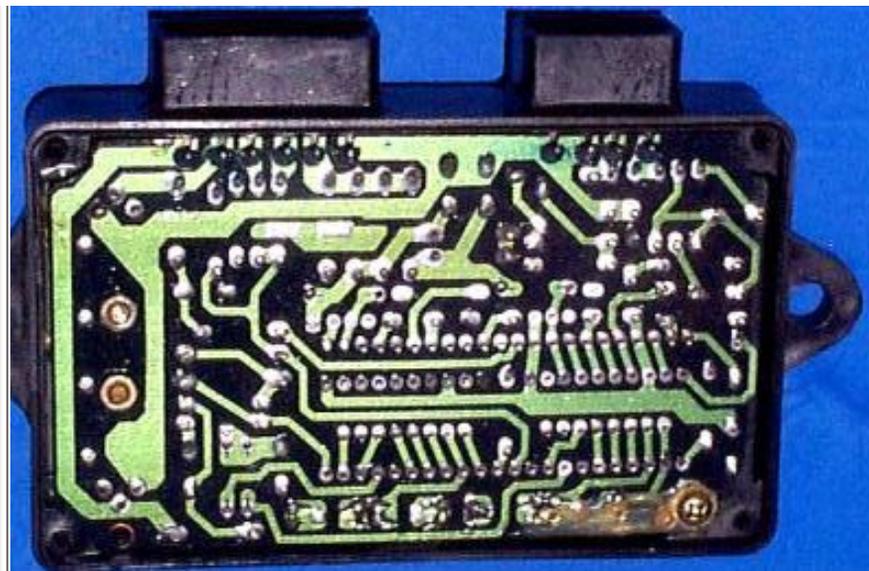
Photo above is bottom of circuit board (bottom cover is removed).
